To Laycock or not to Laycock??

Trials & Tribulations of TR6 Clutches

Brent Kiser

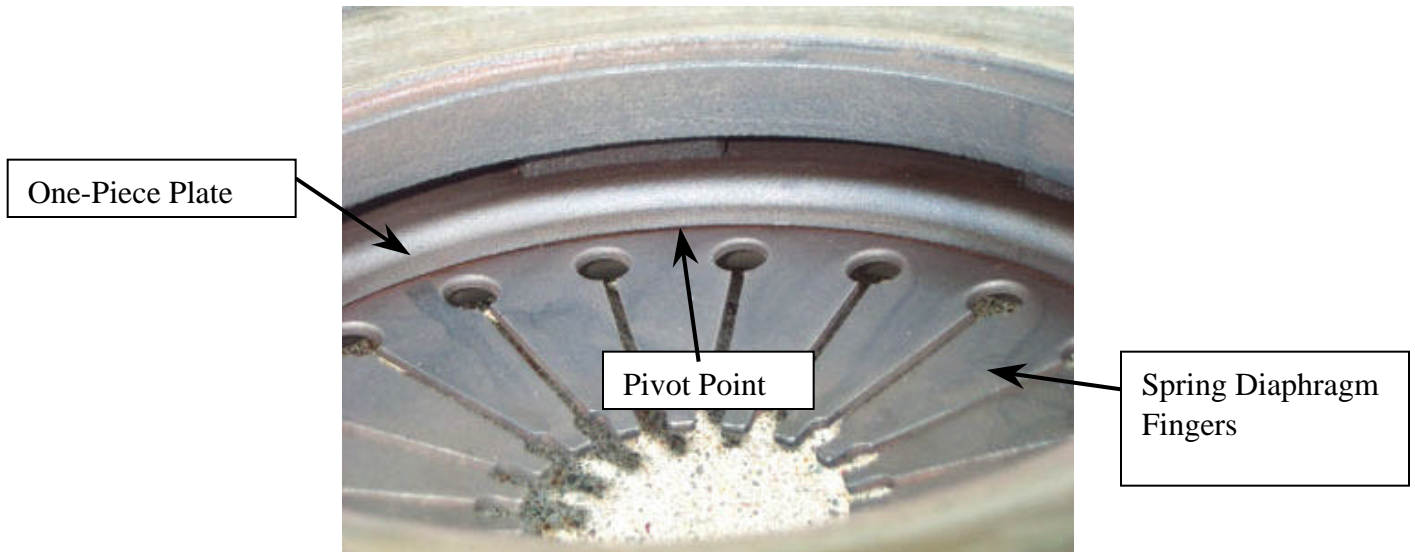
Original Laycock Pressure Plate

The original Laycock has a solid, one-piece plate for all of the fingers of the spring diaphragm to pivot about when the clutch was released. Plus, the pivot point was outside of the point where the fingers of the spring diaphragm joined. This design creates a solid, single plain for all of the spring diaphragm fingers to rotate about.

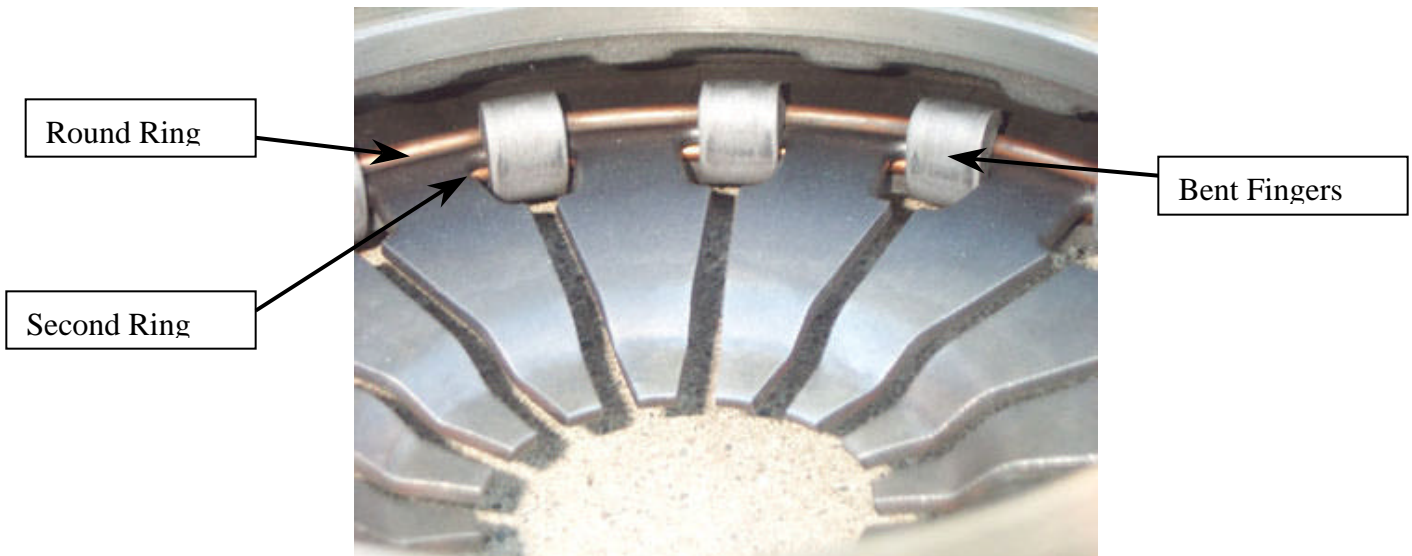
Aftermarket Borg & Beck

The aftermarket Borg & Beck has two round rings held in place by several bent fingers on the cover plate as the fulcrum point for the diaphragm spring fingers. Plus, the fingers joined outside of the round ring.

Bottom line: The aftermarket Borg & Beck design would be almost impossible to mass produce with the exacting tolerances required to assure all of the fingers pivoted about the same plain. Having multiple pivot points at different plains would cause the binding and sticking seen on engagement of the pressure plate.

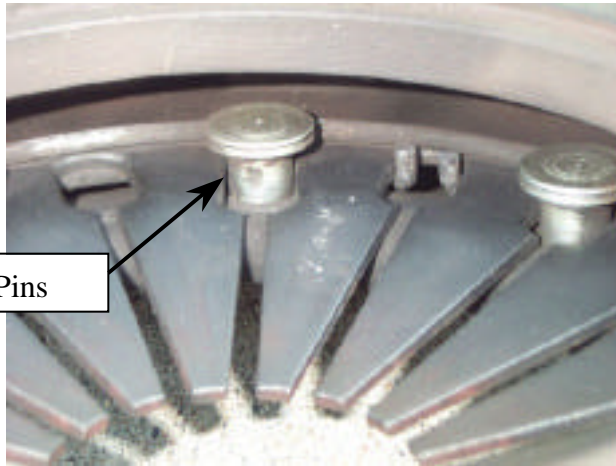
Original Borg & Beck

It became obvious at first glance that the original and aftermarket Borg & Beck pressure plates are not even close to the same design. The original Borg & Beck is what I call a “Pin Design” pivot point versus a “Bent Finger” pivot point.

As you can see in the pictures, there is a great difference between the original and aftermarket units. It is no wonder that people have been telling me their original Borg & Beck work great and I have claimed the Borg & Beck does not work. We were talking about two different designs!!

Since discovering this difference, I have installed over six rebuilt original Borg & Beck pressure plates and have not had any problems. I strongly recommend the rebuilt original Borg & Beck pressure plate.

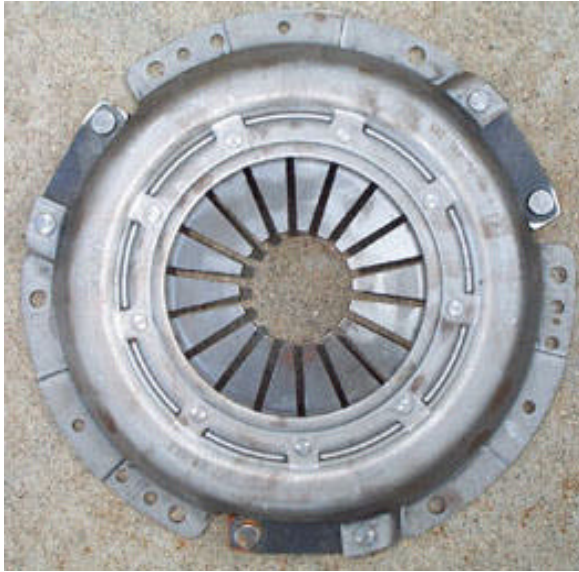
Sachs Cover Side

The design of the Sachs is the better than the aftermarket Borg & Beck it still has too strong of spring. I cannot recommend the Sachs unit.

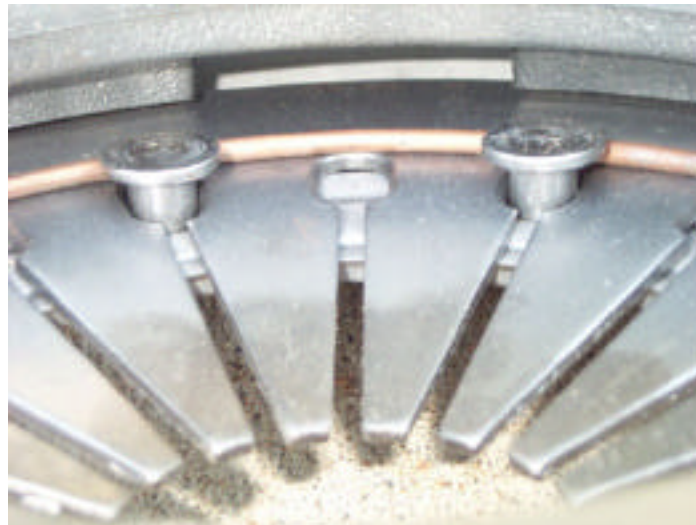
Sachs “Pin Type” Pivot

When you look at the Sachs pressure plate you will see it is like the original Borg & Beck design with the pin type pivot point.
