## TECHNICAL SERVICE BULLETIN

**TRIUMPH**

October, 1971

Recall Campaign # Z.102  
U.S. Safety Weave 201  
Seat Belts

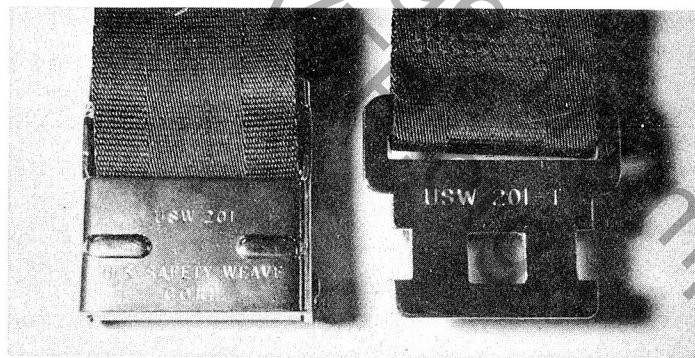
Recent testing of certain seat belts supplied to British Leyland for installation in a limited range of Triumph vehicles, indicates a number of them may not meet the load requirements of Federal Motor Vehicle Safety Standard 209.

These belts were supplied by U.S. Safety Weave Co. and can be identified by the symbol "USW 201" on the reverse side of the buckle and tongue as illustrated:

It will therefore be necessary to replace all U.S. Safety Weave belts bearing the above symbols on Models listed below at no charge to the customer.
