BULLETIN #T-61-17

SUBJECT: RACK AND PINION STEERING UNIT - TRIUMPH HERALD

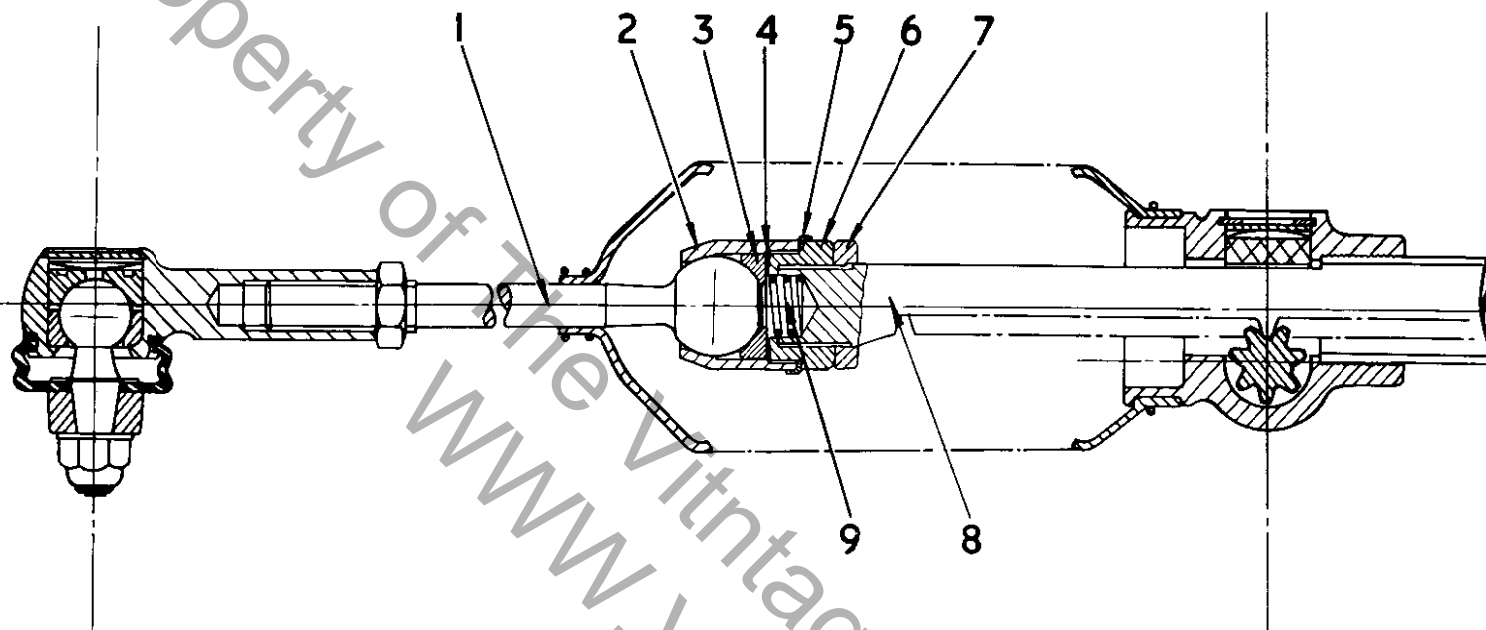
FIG. 1

To prevent over-tightening of an inner ball joint assembly, (reference Bulletin #T-61-20), a new steering unit, incorporating shims for ball joint adjustment, has been introduced from Commission Numbers:

The redesigned inner ball joint assembly permits detachment and re-attachment of the steering tie-rod to the rack without the need for re-adjustment, provided that the existing shim pack remains intact and that wear is not excessive. Should either condition permit "ball-lift" in excess of 0.002", then re-adjustment will be necessary.

1. Release the rubber bellows and move this clear of the ball joint.
2. Slacken the locknut (7) and remove the ball joint assembly by unscrewing the sleeve nut (6) from the rack (8).
3. If necessary, dismantle the ball joint by releasing the lockplate (5) and unscrewing the sleeve nut (6) from the cup nut (2).

1. Slide the cup nut (2) over the tie-rod (1) and insert the thrust ring (3) into the cup.
2. Position the lockplate (5) over the sleeve nut (6) and screw this fully into the cup nut.

3. With the cup nut held in a vise, pull and push the tie-rod to estimate the approximate amount of "ball-lift".
4. Prepare a shim pack (4) slightly thicker than the estimated "ball-lift" and insert this between the thrust ring (3) and the sleeve nut (6).
5. Add or remove shims to obtain the requisite .002" ball-lift when the sleeve nut is firmly screwed into the cup nut.

The ball should now move freely in the joint. If tightness occurs at any point, increase the shim thickness sufficiently to overcome this.

6. When adjustment is satisfactory, lock the assembly by bending the lockplate (5) over the sleeve nut (6) and the cup nut (2).

1. Screw the locknut as far as possible on to the end of the rack (8).
2. Insert the spring (9) into the end of the rack and screw the ball joint assembly as far as possible up to the locknut.
3. Finally tighten the ball joint against the end of the rack and secure the joint in this position by tightening the locknut against it.
4. Repack the bellows with grease ( $\frac{1}{2}$  oz. Retinax "A" from dry) before securing this in position.
