BULLETIN: #T-61-35

DATE: December 4, 1961

SUBJECT: HERALD INNER AXLE SHAFT

# INNER AXLE SHAFT (MODIFIED CIRCLIP GROOVE)

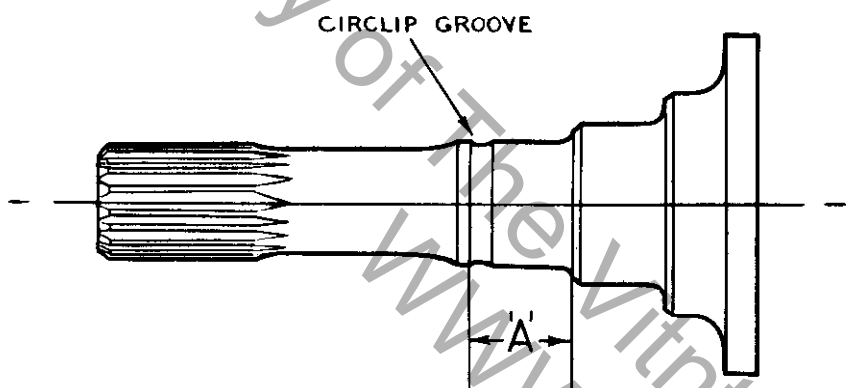
SECTION THROUGH CIRCLIP (PART No. 132650)

PART No. 132649 — DIM. 'A' 0.643/0.648 (16.33/16.46mm)  
PART No. 117661 — DIM. 'A' 0.683/0.685 (17.35/17.40mm)

Inner half shaft rear axle assemblies of units from commission numbers GA-35604 and Y-31501 incorporate a revised circlip groove. These shafts may be used to replace the earlier type, provided that the revised circlip is also fitted and the existing thrust washer discarded.

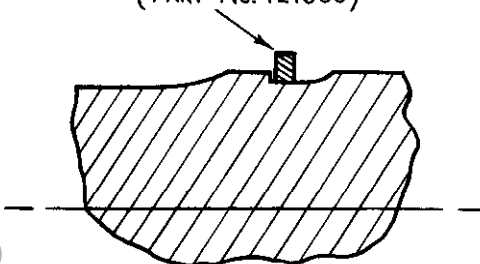
ENLARGED VIEW OF EARLIER TYPE  
CIRCLIP GROOVE (PART No. 117661)

SECTION THROUGH CIRCLIP  
(PART No. 121680)
