BULLETIN: #T-62-10

DATE: April 16, 1962

SUBJECT: PLUNGER RETAINER (RACK & PINION ASSY.)TRIUMPH HERALD

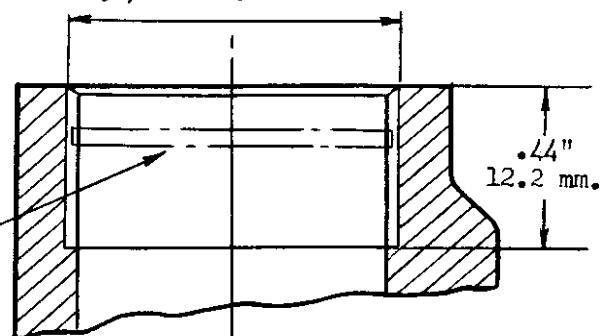
BOSS TAPPING DETAILS.

15<sup>11</sup>/<sub>16</sub> UNF. 16 T.P.I.

1. Remove and dismantle the steering unit as described in the Service Manual (Group 4).
2. Tap the plunger boss housing to a depth of  $\sim .44"$  (12.2 mm). using a 15/16" UNF. 16 TPI tap.
3. Thoroughly clean the housing and pack with the correct grade of grease when refitting the rack and pinion.
4. Fit new plunger 120946; spring 126765; and screwed cap 132053; placing two packing washers 133745, and sufficient shims 120949 and 120959 between the cap and housing to obtain correct end float.

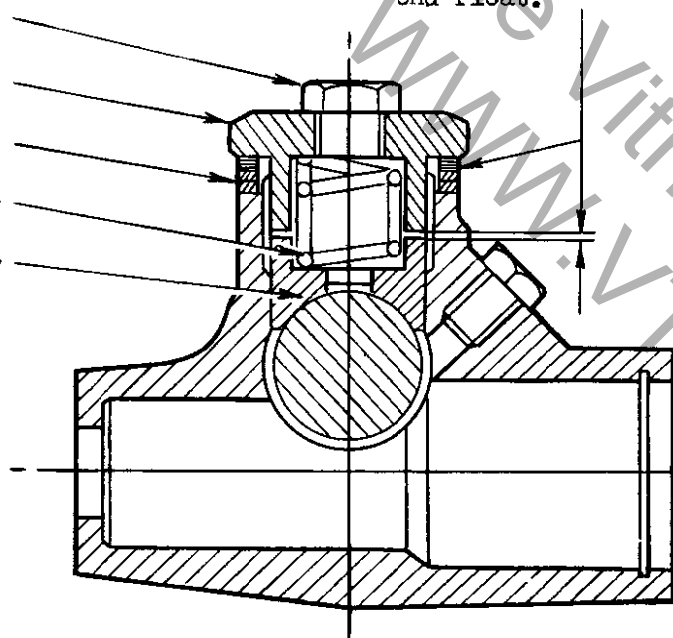
Use shims 120949 and 120959  
as required to give 0.004" -  
0.008" (0.1- 0.2 mm.) plunger  
end float.

This method of securing plunger may  
be incorporated on Part Number 205628  
and 304737 when serviced for complaint  
of circlip not holding in position.

Some steering units incorporate a circlip and spring plate to retain the plunger in the rack and pinion assembly. Should circlip failure occur, modify the unit to the current screwed cap and spring method of retaining the plunger, as illustrated overleaf and described below:
