BULLETIN: T-62-42

DATE: August 6, 1962

SUBJECT: Bumper Control Strap TR-4  
(Commission No. 5000 and up),  
and all TR-3b's.

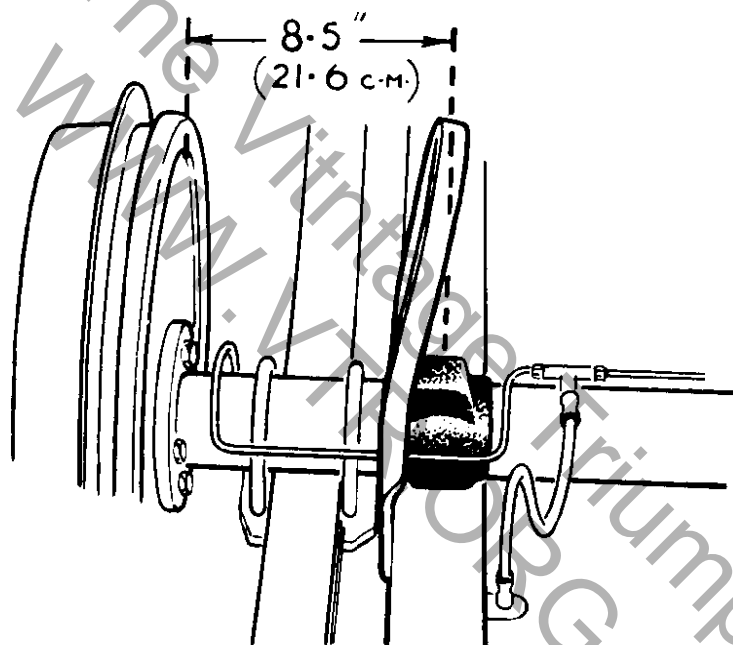
Under full bump conditions, unless this bump control strap is in the correct position, it is possible for the control strap to foul the brake pipe from the three-way connection to the offside rear wheel cylinder.

When checking the bump control strap, it is IMPERATIVE that inspection be made of brake pipe part #208286 which leads from the three-way connection to the right rear wheel brake cylinder. It is important to do this as it is possible there is already damage to the brake tube at the point where the brake tube leads from the three-way connection. It will be necessary to remove the brake pipe part #208286 to inspect the pipe for damage which may already have occurred and which ordinarily would be concealed by the pipe nut.

We are attaching a drawing showing the proper location of the bump control strap and the pipe nut on the three-way connection which must be unscrewed in order to check the brake pipe which leads from the three-way connection to the right rear wheel brake cylinder.

A considerable variation in position may exist from car to car and all straps should be reset by hand to a distance of 8-1/2" (21.6 cm) from the outer top edge of the strap to the inner top face of the brake back plate.
