BULLETIN T-63-59A

SUBJECT: TRIUMPH HERALD, TRIUMPH 1200  
AND SPITFIRE GENERATOR  
REINFORCING BRACKET

DATE: SEPTEMBER 6, 1963

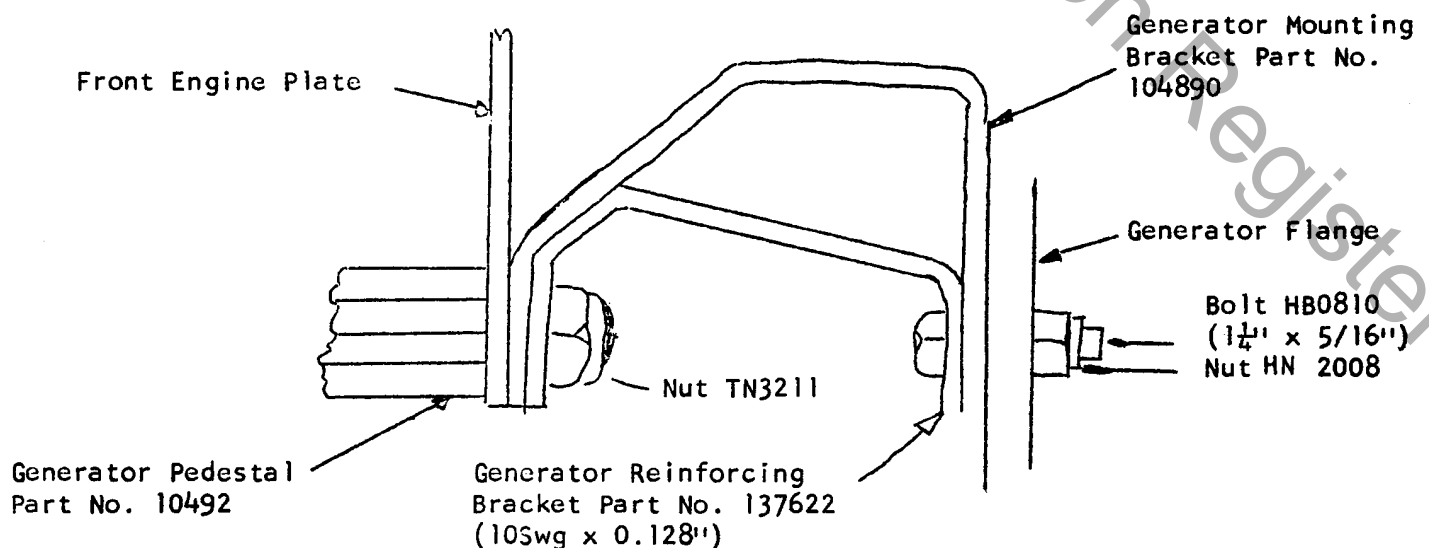
Should a failure of the generator mounting bracket occur on any of the above models, the bracket should be replaced by the following details which include an additional reinforcing bracket.

The diagram shown below illustrates the location of the additional reinforcing bracket.

| Generator mounting bracket | 104890 | 1 off |
| Generator reinforcing bracket | 137622 | 1 off |
| Generator bolt | HB0810 | 1 off |
| Generator bolt nut | HN2008 | 1 off |
