BULLETIN T-64-20

SUBJECT: TRIUMPH SPITFIRE BODY WATER LEAKS

DATE: JULY 2, 1964

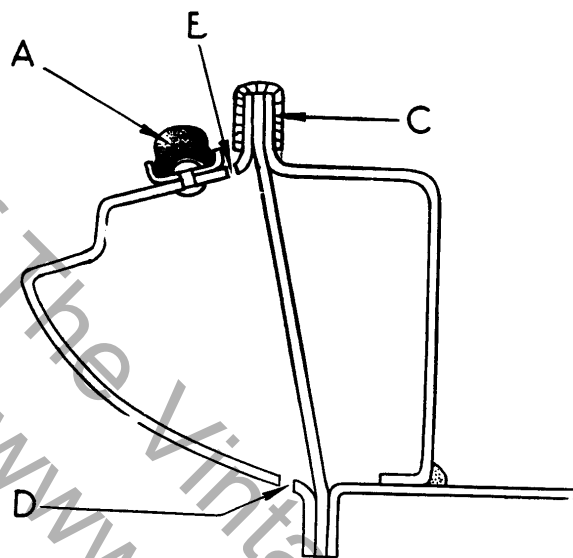
FIG. 1.

8. To prevent a build up of water at the base of the door, early cars were fitted with a separate door rubber seal inserted in a channel pop-riveted to the door aperture. "A" Fig. 1. Assist the drainage by drilling three equidistant 3/16" die. holes in the top of the body sill panel in-board of the riveted channel at the bottom of the door aperture. "B" Fig. 1. To allow drainage from the body sill, a drain hole 1/4" dia. should be drilled at the rear wheel arch end of the outer sill panel at its lowest point. "C" Fig. 1

The later type of door aperture sealing rubber, part No. 707931, which combines the aperture sealing rubber and aperture flange finisher may be fitted. "D" Fig. 1. The original channel for the older type rubber should be retained as the new rubber fitted to the aperture flange will almost conceal it.
