BULLETIN T-64-41

SUBJECT: TRIUMPH TR-4 WINDOW  
WINDER REGULATOR

DATE: DECEMBER 10, 1964

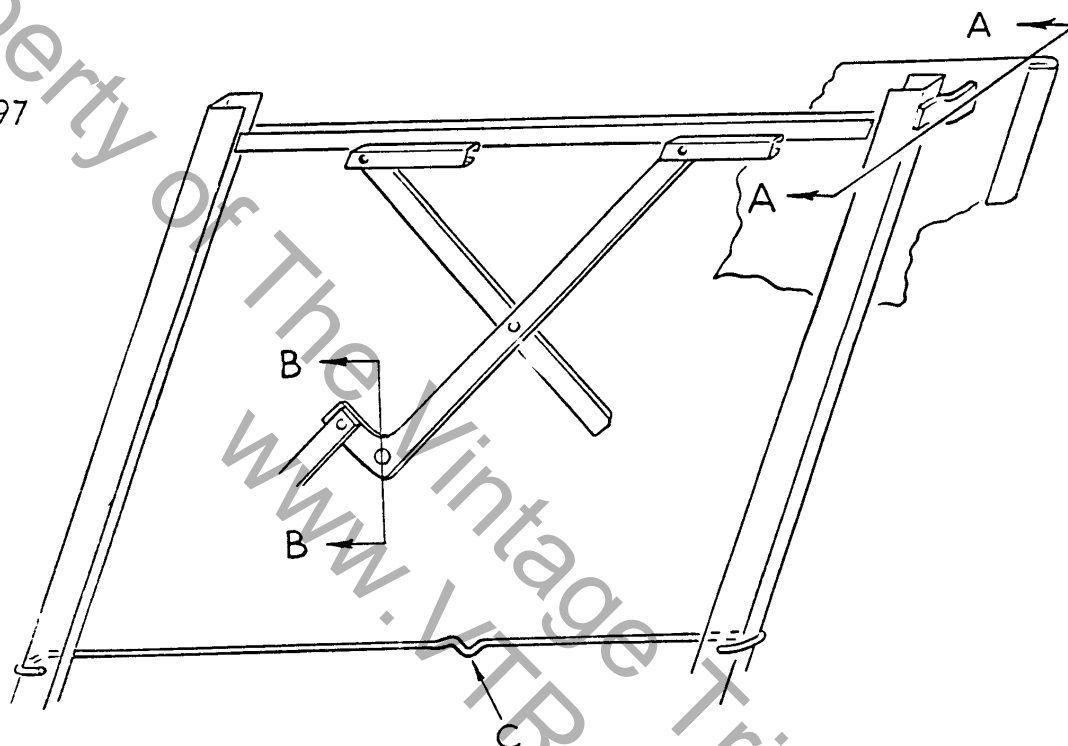
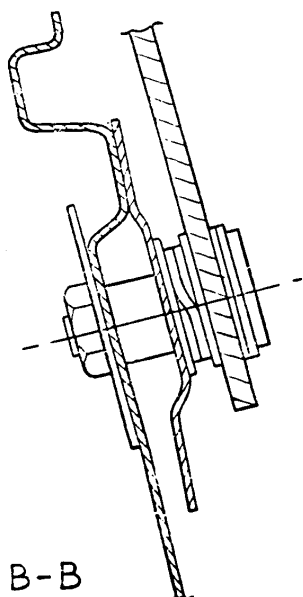
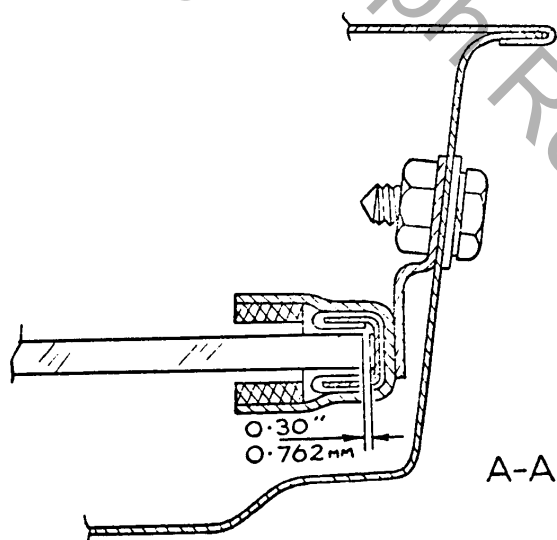
A-A

When reports of stiffness in the operation of the door glass are received, the following procedure should be adopted which will prevent straining and damage to the regulator. The same instructions should also be followed when renewing a regulator.

1. Remove trim panel.
2. Raise window and check the clearance of the glass fore and aft in the top of the rear channel. The recommended clearance is .030" which should be maintained for the whole length of the channel. Excess clearance will allow tilting and the jamming of the glass and insufficient clearance will produce stiff operation. Clearance can be obtained by the use of packing washers between the inner door panel and top channel bracket (see illustration A-A).

3. Adjust bottom brackets and crimp the tie rod to ensure that the channels are parallel (illustration C).
4. Remove regulator pivot pin nut and delete spring washer under head of nut. Add washer WP0119 1/2"x 7/8" x .050" behind head of pivot bolt and additional washer WP0160 5/16" x 1 5/8" x 16 S.W.G. behind head of nut (illustration B-B).

5. Tighten nut sufficiently to allow ease of operation and peen or center pop end of thread.
6. Refit trim.
