SUBJECT: TRIUMPH HERALD, TRIUMPH 1200  
AND SPITFIRE - GENERATOR  
REINFORCING BRACKET

BULLETIN T-66-23  
(Originally issued as  
T-63-59A)

DATE: MARCH 29, 1966

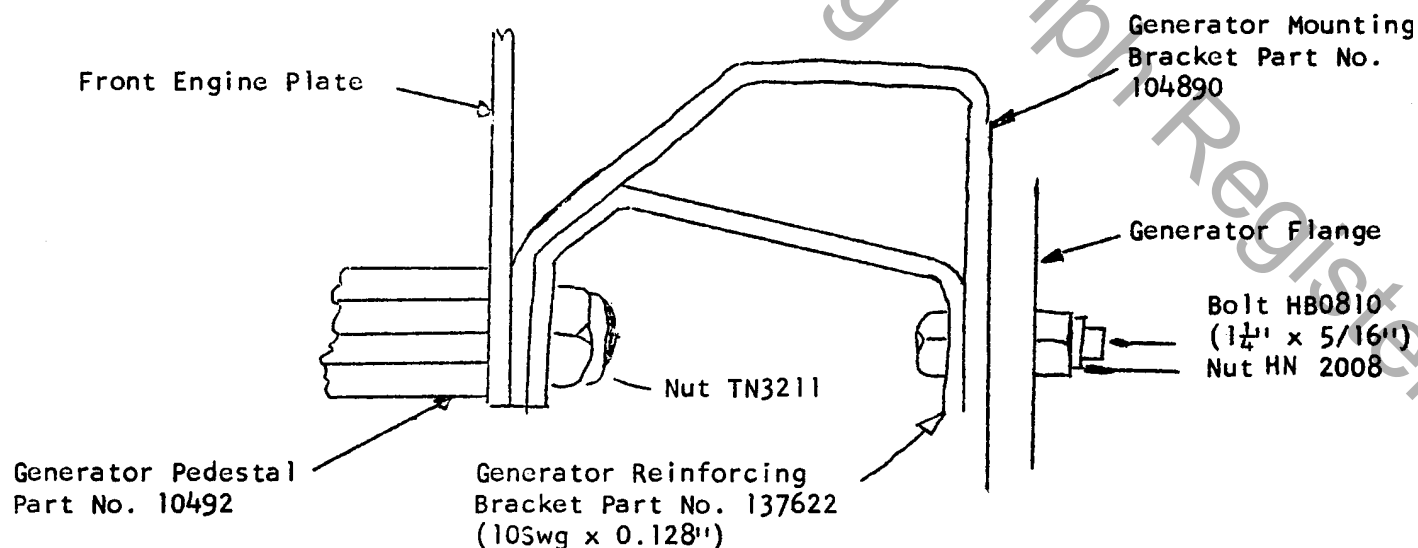
Should a failure of the generator mounting bracket occur on any of the above models, the bracket should be replaced by the following details which include an additional reinforcing bracket.

The diagram shown below illustrates the location of the additional reinforcing bracket.

| Generator mounting bracket | 104890 | 1 off |
| Generator reinforcing bracket | 137622 | 1 off |
| Generator bolt | HB0810 | 1 off |
| Generator bolt nut | HN2008 | 1 off |
