## TECHNICAL SERVICE BULLETIN

1-A-5

OIL PUMP SCREEN

TR-6 and GT-6+

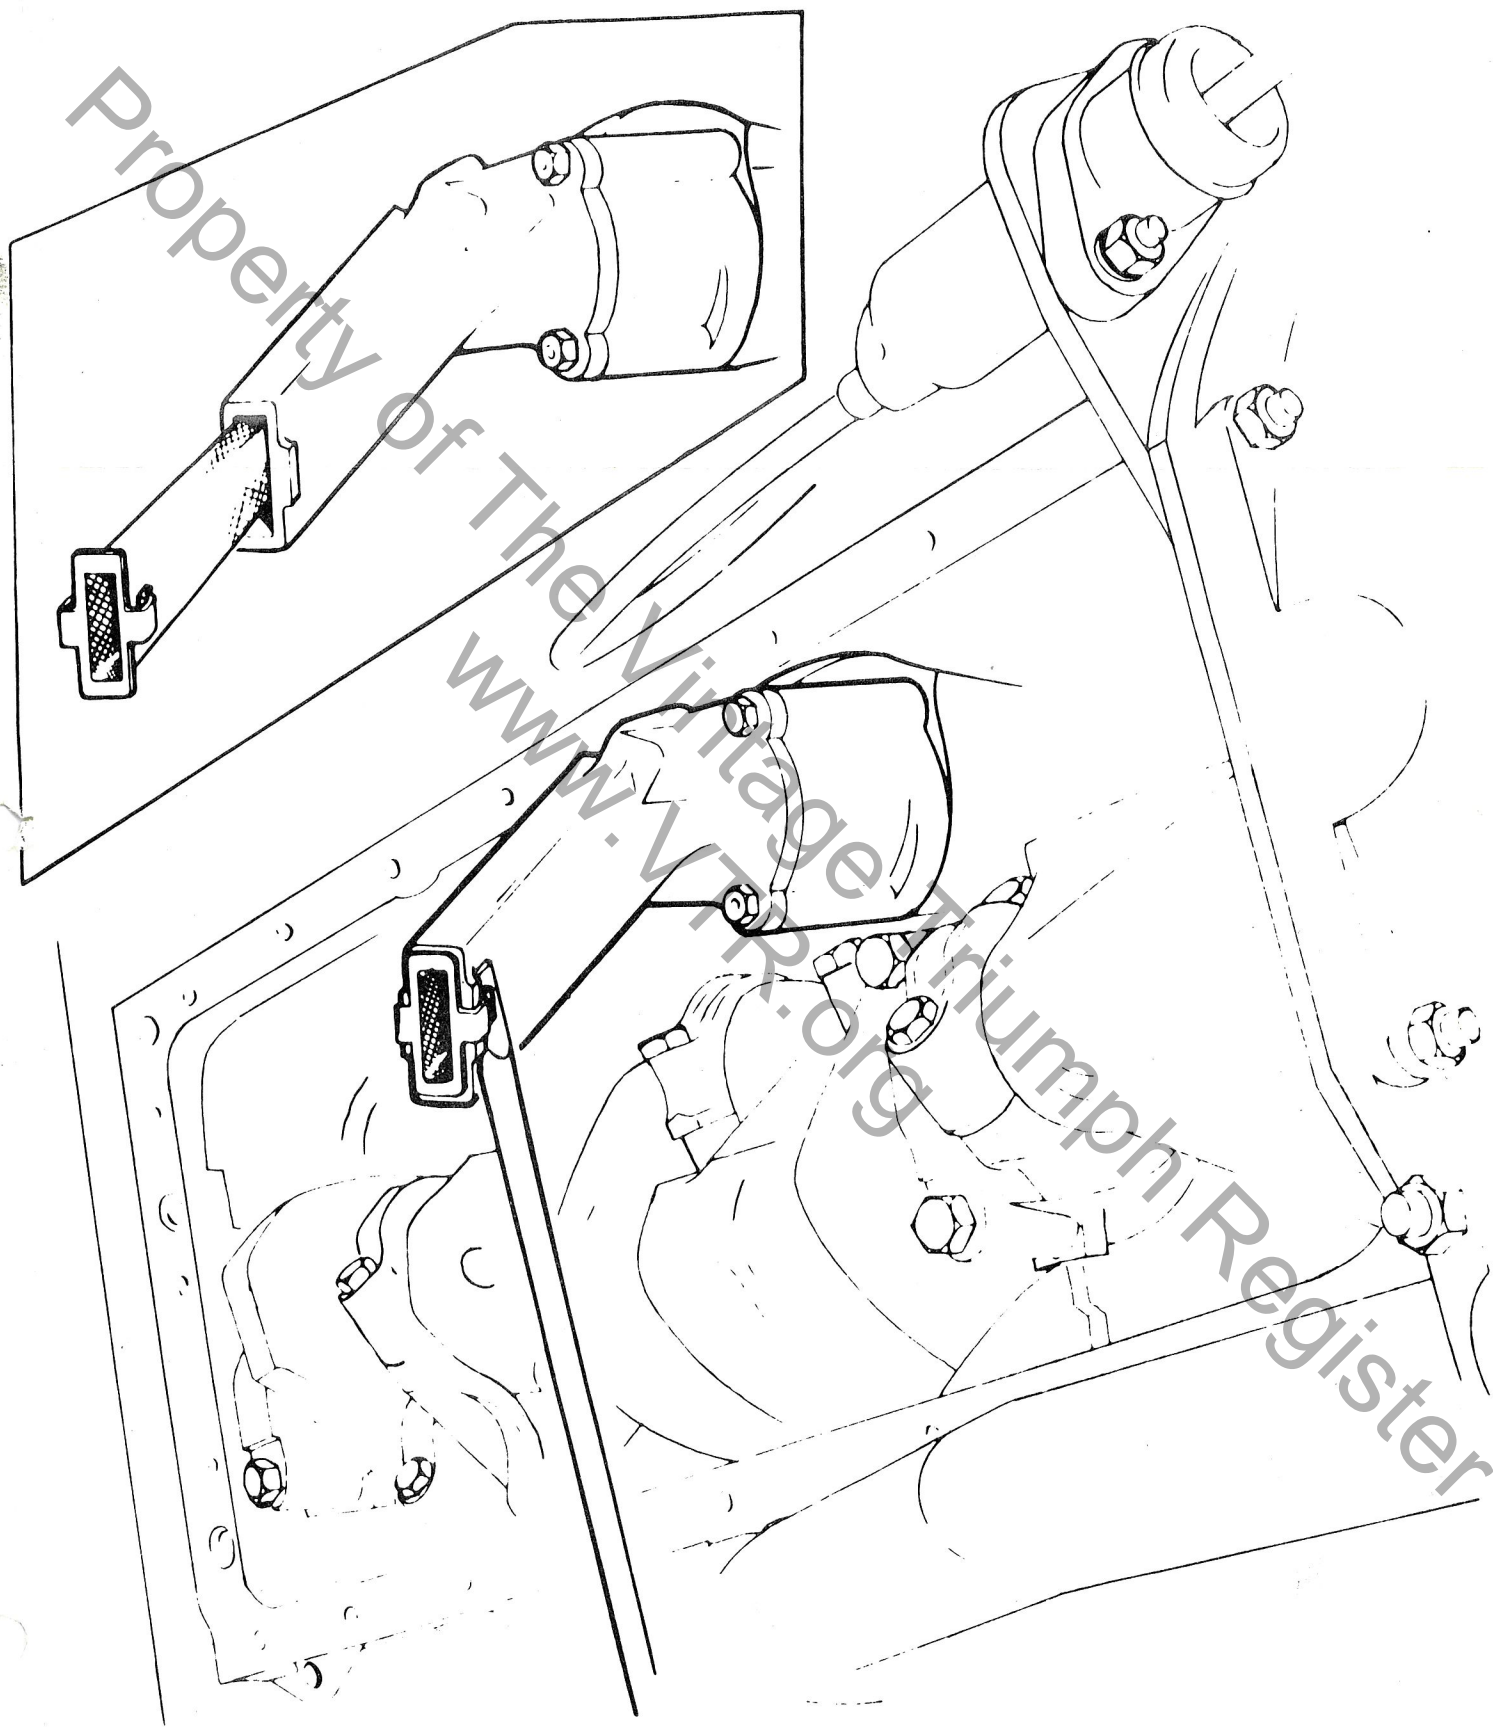
It has been established that the metal gauze filter located on the intake of the engine oil pump can under certain running conditions become partially blocked, restricting the oil pressure to such a degree that serious damage can be caused to the engine.

- 1) Remove the oil pan.
- 2) Pry out the pump pickup screen with a screwdriver and discard.
- 3) Replace the oil pan (see attached sketch).

- 1) Remove the oil pan retaining bolts and pull the rear of the pan away from the engine block as far as possible, taking care not to damage the pan gasket.
- 2) Ease out the bottom left-hand corner of the pliable valance. This will allow the hand to be inserted into the oil pan area, and with the aid of a small screwdriver, remove the pump pickup screen and discard.
- 3) Replace the oil pan.
- 4) Add a dab of white paint to drain plug to indicate oil screen has been removed.
