# TECHNICAL SERVICE BULLETIN

Stop Light Switches

Spitfire MK III, GT-6+

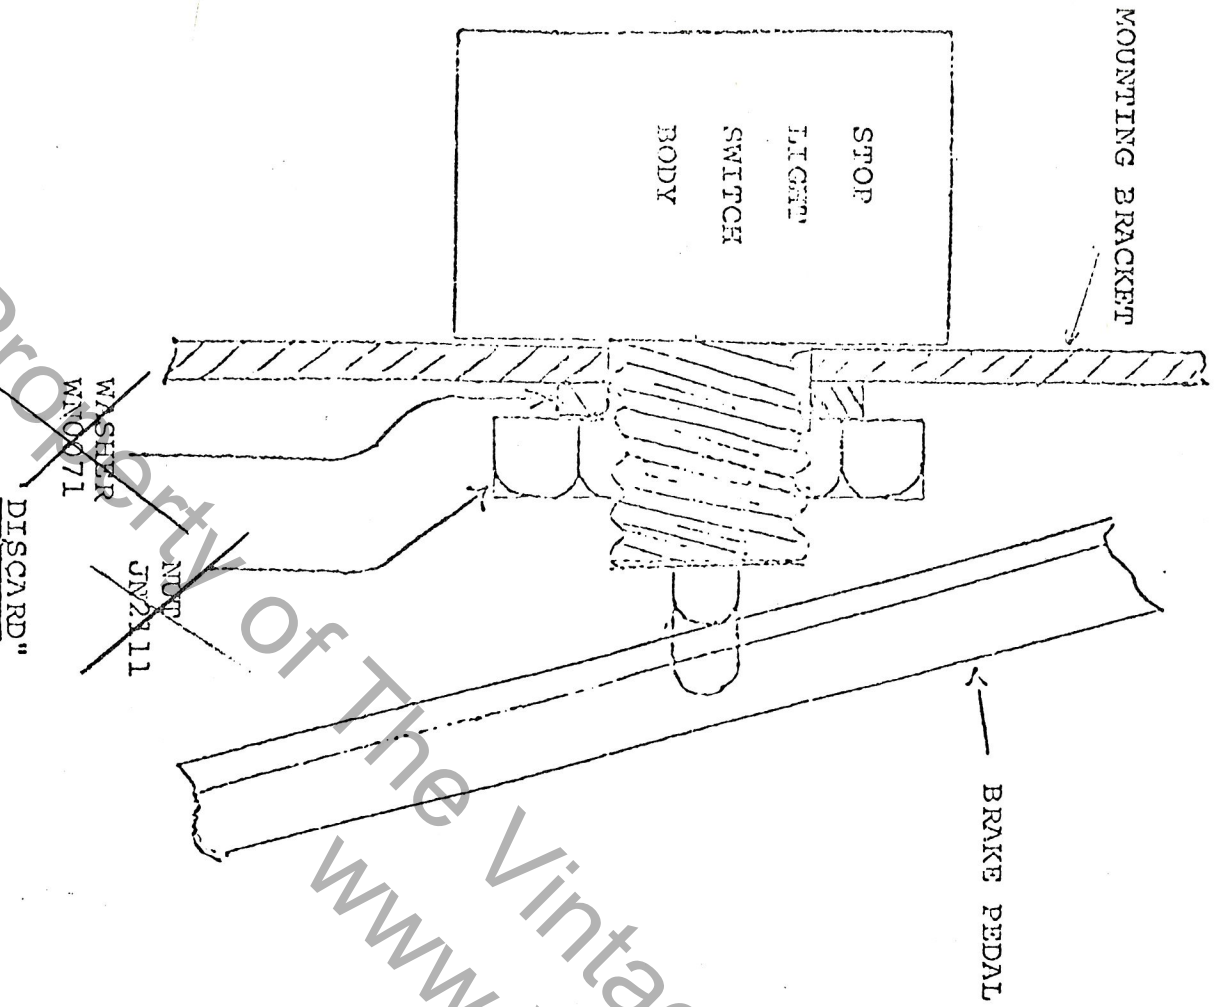
OLD CONDITION

A modification is now in effect in order to prevent premature failure of the stop light switches, Part #134529, due to the switch being physically damaged by the brake pedal lever.

The modification consists of removing the switch assembly from its mounting bracket. Discard the fixing nut, Part #JN 2111, and plain washer, Part #WM 0711. Refit the switch to its mounting bracket but first place a new plain washer over the threaded portion of the switch between the mounting bracket and the switch body, as shown in the attached sketch. Fit a new nut, this has the effect of increasing the clearance between the switch plunger and the brake pedal. The thicker nut will also act as a pedal stop. Retroactive action is not considered necessary.

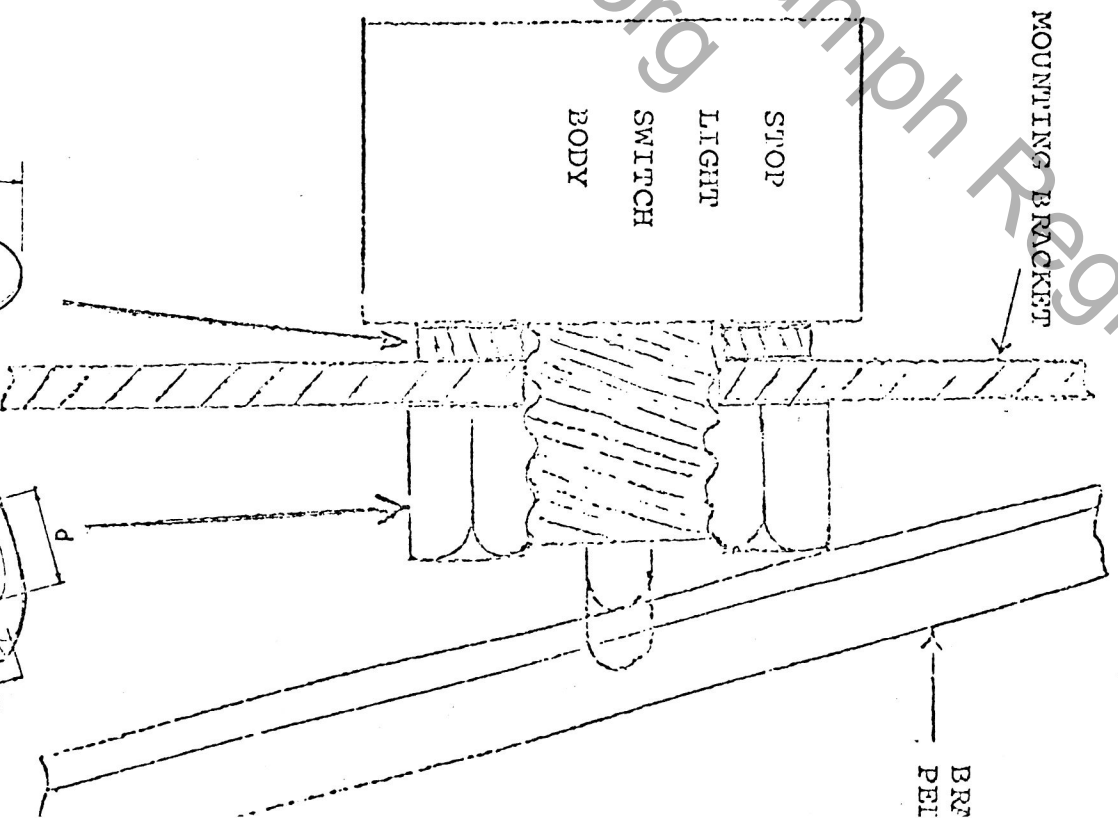
NEW CONDITION

Washer Dimensions:-  
B = 1"  
d = 1/2"

Nut Dimensions:-  
A = 3/4" A  
d = 1/2" UNF
