LEYLAND-TRIUMPH SALES COMPANY, INC.

BULLETIN T-66-26

SUBJECT: SPECIAL SAFETY CHECK  
CAMPAIGN - BRAKE PIPE  
FOR IMMEDIATE AND URGENT ACTION

DATE: APRIL 27, 1966

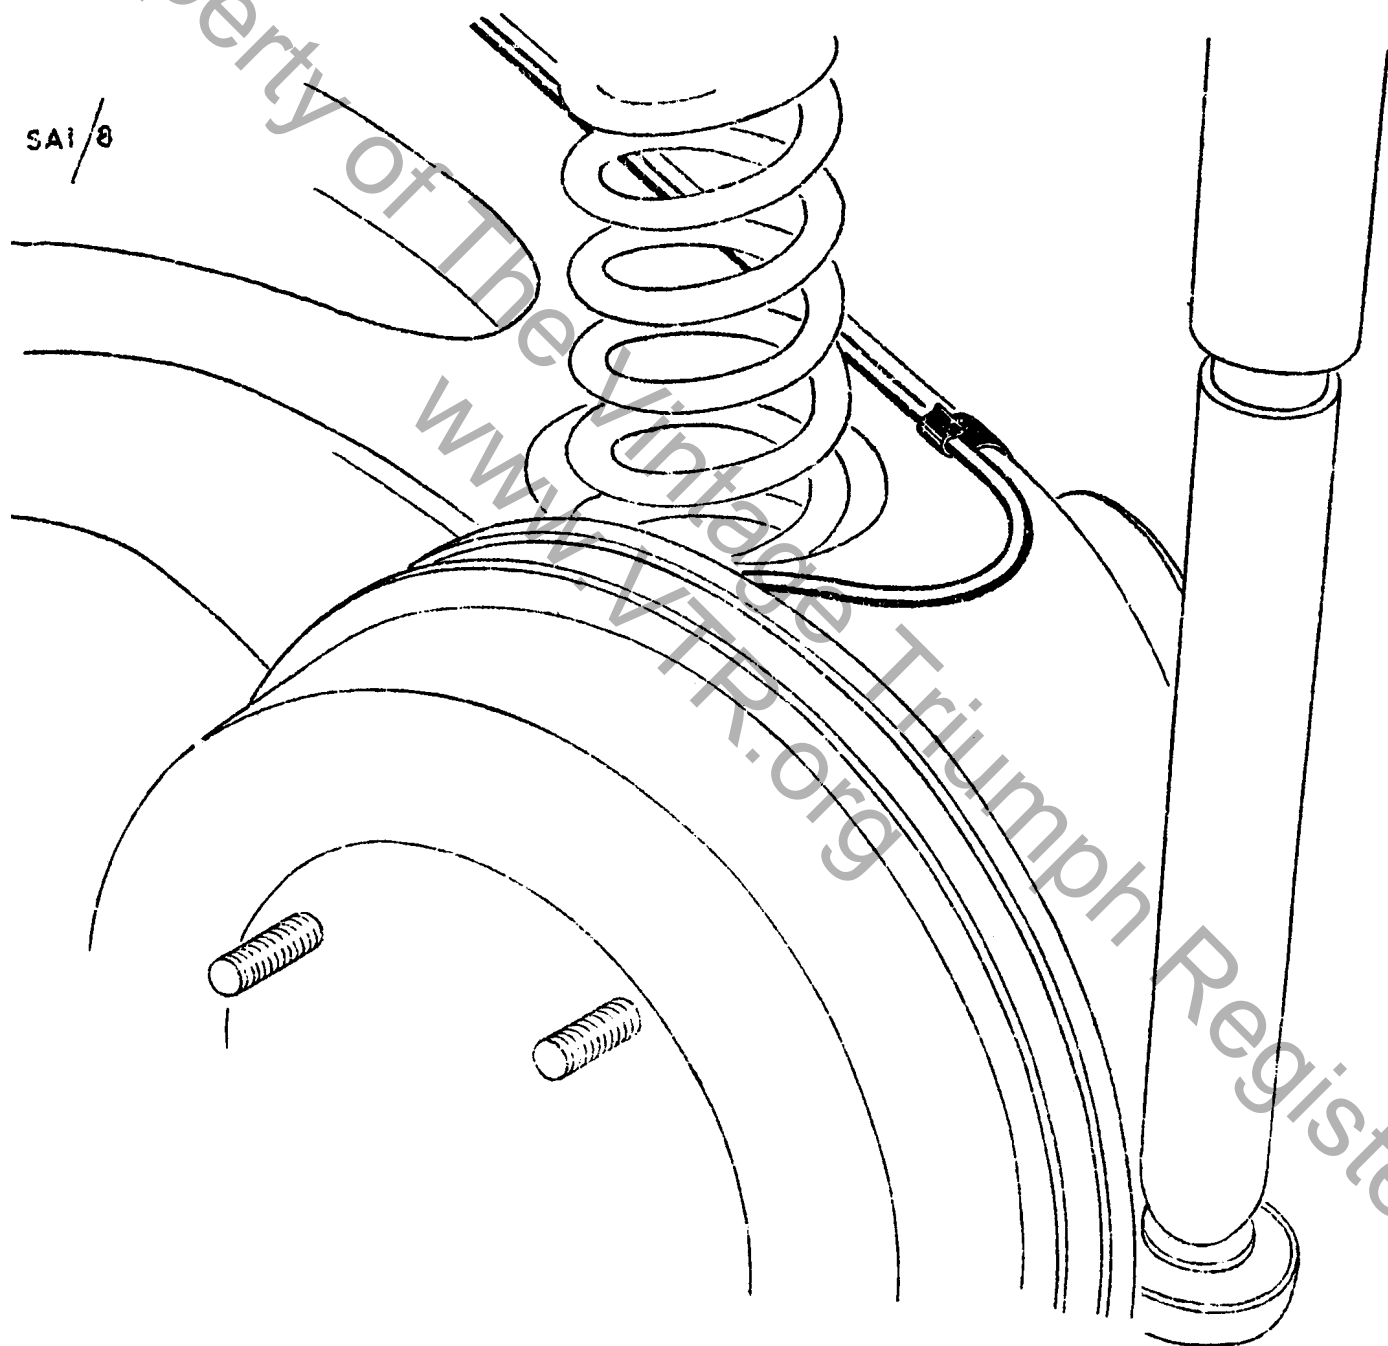
SA1/8

All Triumph 2000 cars sold through your organization should be called in immediately for the position of the brake pipes on the trailing arms to be examined to ensure that they have adequate clearance from the coil spring.

The correct and firm clipping of the brake pipe to the trailing arm should also be checked.

An illustration showing the location of the pipe and the position of the clip is attached.

Pipes should be reset where the clearance is less than 1" and if damaged should be replaced.
